D5 Qualitative and quantitative hydrological monitoring

LIFE Tritó Montseny (LIFE15 NAT/ES/000757)

Annual reports on the scientific assessment of hydrological variables. 2020-2022

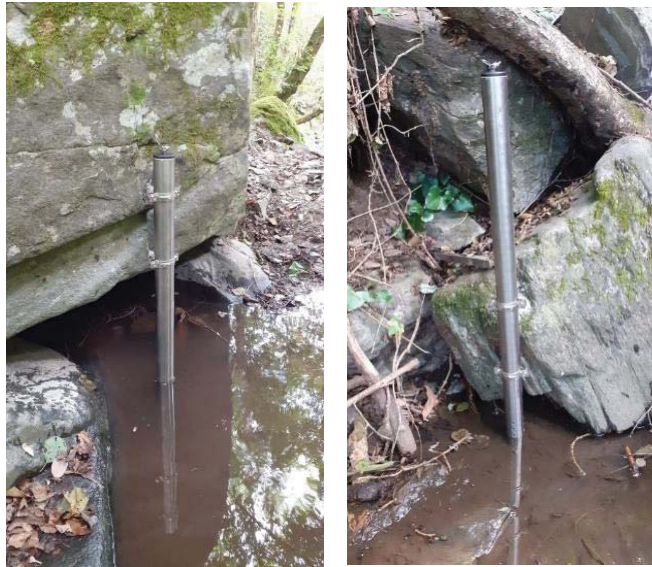
These sensors continuously measure the water flow. They are installed in a small pool in the river bed inside a tube that acts as a small well. This method is very minimally invasive as it does not involve any modification of the river habitat. Unfortunately, we found that the streams in which the newts live have a very high the newt have very torrential responses, which the conventional installation of conventional sensor installation could not cope with.

Fig. 1: Sensor installations in brooks with steel pipes and anchored to rock blocks. October 2021.

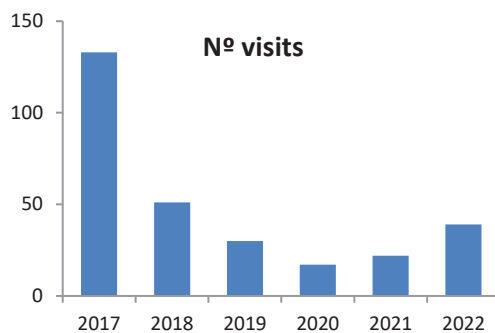
Fig. 3: Total number of visits per year to assess hydrological status for all brooks.

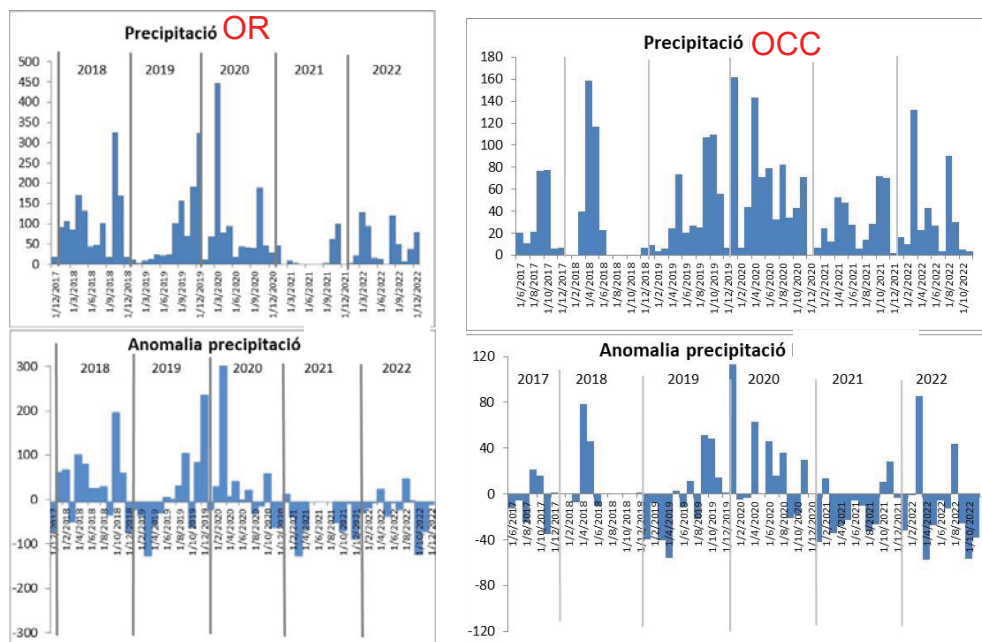
Fig 5 Monthly rainfall at the eastern sector and western sector weather stations. The vertical lines mark the months of January. Bottom: Difference of the monthly temperature with respect to the average of the time series.

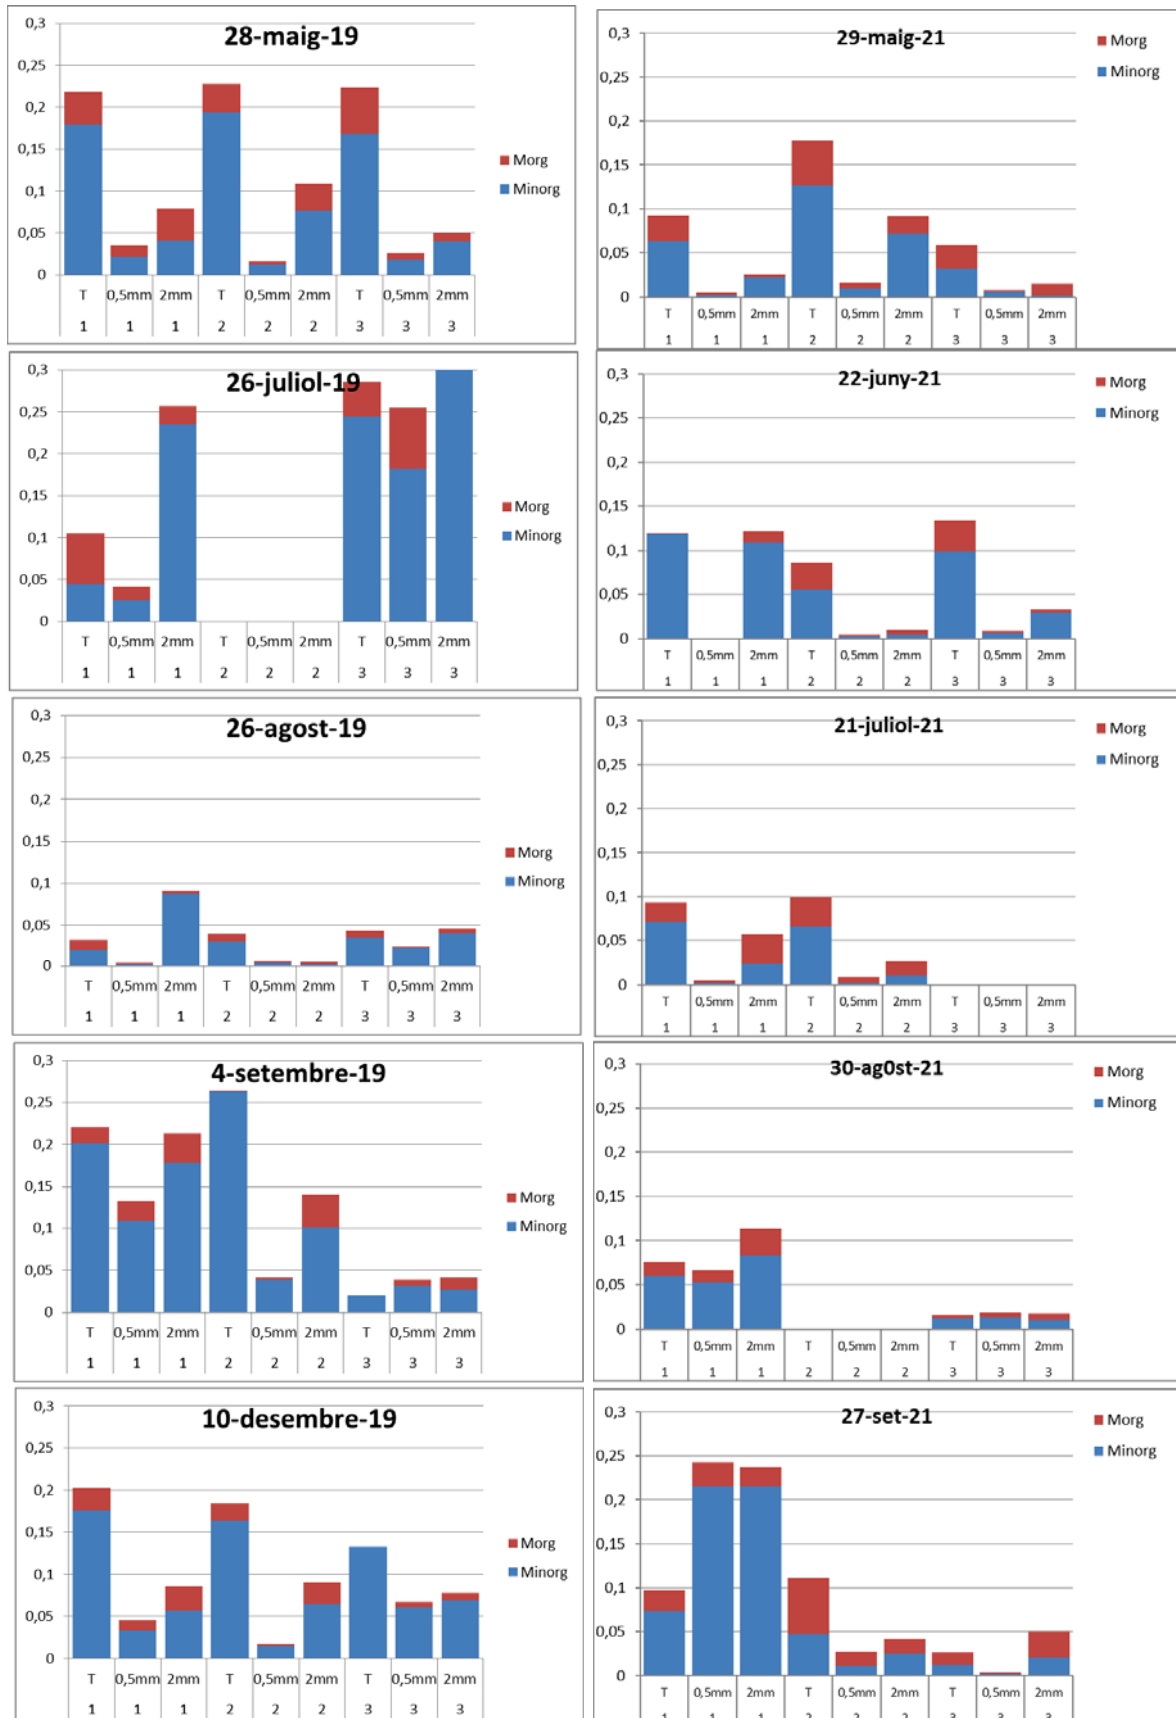
Fig. 9 Sediments transported -gr/day- in B6 of inorganic (blue) and organic matter (red), separated in 3 size classes: 2mm: greater than 2mm; 0.5mm: greater than 0.5mm and less than 2mm and T: less than 0.5mm; in localities: 1.- point above the track, 2.- point below the track, 3.- point downstream. Right column: pre-action samples, left column: post-action samples. The X indicates the lack of data due to the disappearance of the traps.

There is no change in the sediment transport due to the improvement of the B6 channel. The amount of sediment transported is very variable, both in the different parts of the river and in time, as well as in the size of the sediment. No pattern can be observed for any of the factors involved (Fig. 12).

There are no differences between before and after the intervention, even the sediment amounts measured in the post-intervention period are slightly lower, although not significantly different. There are no differences due to the distance from the work site. If there had been a release of sediment due to the work, we would expect to see more sediment in the water below the bridge. There are also no differences between the sizes of sediment fractionation, with no change observed after the works, where a greater amount of fine sediment would be expected. There is also no pattern of change in sediment transport according to the month studied, where we would expect less mobilisation in the summer months due to lower flow.

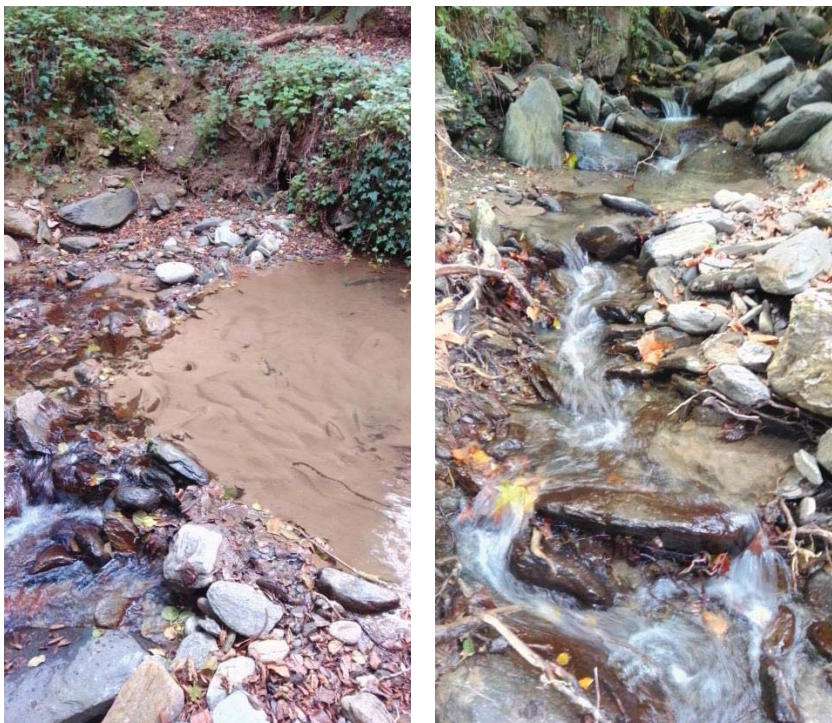
Fig10: Significant accumulations of fine sediments in pool 3 of the A1 stream (left) and areas of flowing water between pools 1 and 2 free of these sediments (right).

From the outset, it was observed that large amounts of sediment were indeed accumulating downstream of the bridge. However, this material only accumulated in the areas of the pools and not in the areas of the riffles. In other words, the areas where the water speed was slower were decantation areas.

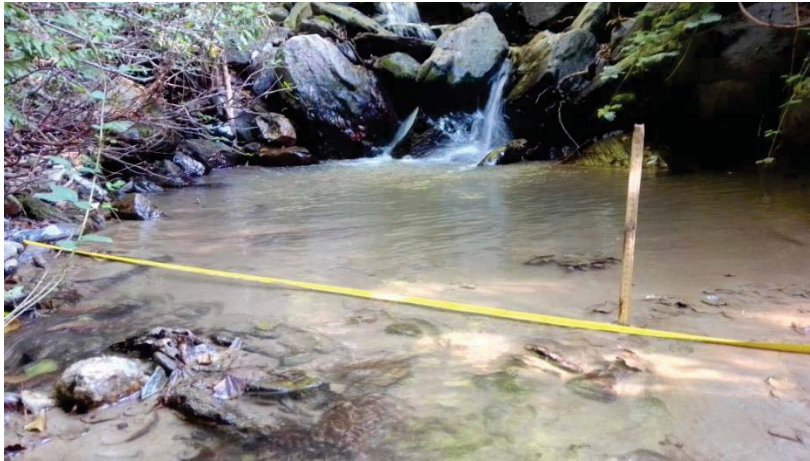
Fig 11: Transect where sediment thickness is measured in Pool 2.

To determine the dynamics of these sediments, the amount of sediment accumulated in 5 pools downstream of the bridge was measured. The amount of accumulated sediment was measured as the proportion of the water column occupied by sediment: the thickness of the sediment layer in relation to the total depth of the pond. Along a transect in the widest part of the pond, the total depth of the pond and the depth of the sediment layer were measured every 10 cm.

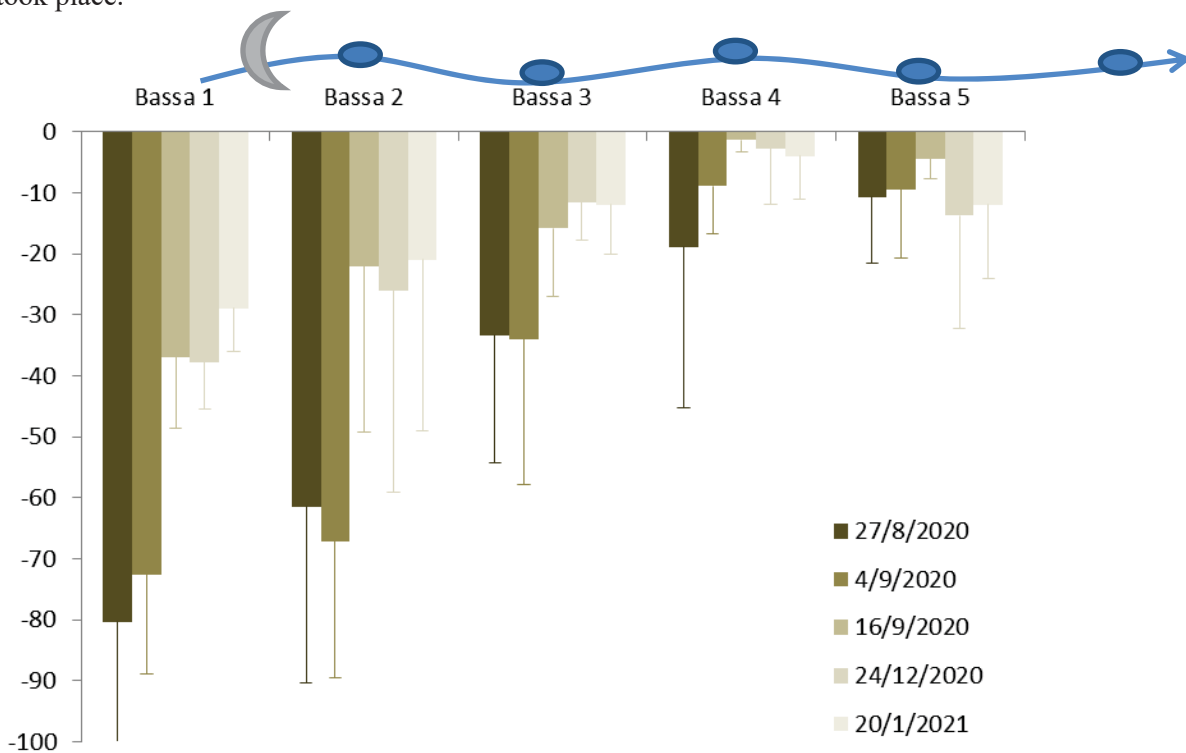
Fig 12: Percentage of pool depth occupied by sediment. Pool 1 is closest to the bridge where the restoration took place.

The results showed that the accumulation of sediments is more important the closer to the bridge and that these were mobilised quite slowly over time, they were quite persistent since 5 months after the first measurement the ponds still had a significant presence of sediments, although the amount in depth had decreased, the extent was quite similar. And they were flow dependent, plus there is more mobilisation, although it seems that a large flood is needed to make them clean. The circulating flow during the sampling period - between 27 August and 20 January 2021. Pools 4 and 5 - the furthest from the bridge - are slowing down sediment loss or even tending to increase sediment accumulation in recent days. They may be receiving sediment transported from upstream accumulation areas.

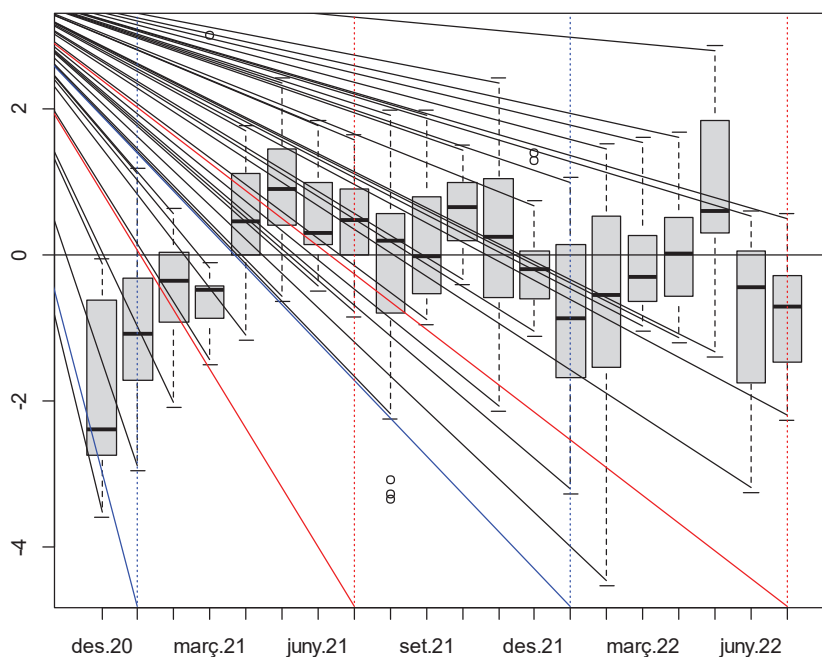
Fig 13: Boxplot of the monthly temperature differences between the Sun and Shade sensors (Calculated as Sun minus shade). Positive values indicate higher temperature in the unshaded section, negative values higher temperature in the shaded sections. The blue dotted lines indicate the months of January, the red ones the months of July.

The results show little difference between the temperatures of the two sections, with monthly averages always less than 2 °C different. In most months the temperature is lower in the shaded area, as expected. However, in the winter months it is the other way round, with the unshaded section being colder. This is probably because the vegetation prevents cold air from falling over the stream.
